*FOUNDATION  
INVESTIGATION  
REPORT*

*BARGE CANAL  
FAIRPORT - LOCK 33*

SOIL MECHANICS BUREAU  
NEW YORK STATE DEPARTMENT OF TRANSPORTATION

PHYSICAL CONDITION SURVEY  
BARGE CANAL - WESTERN SECTION  
FAIRPORT TO LOCK 33  
P. I. N. 4940.29 - 101

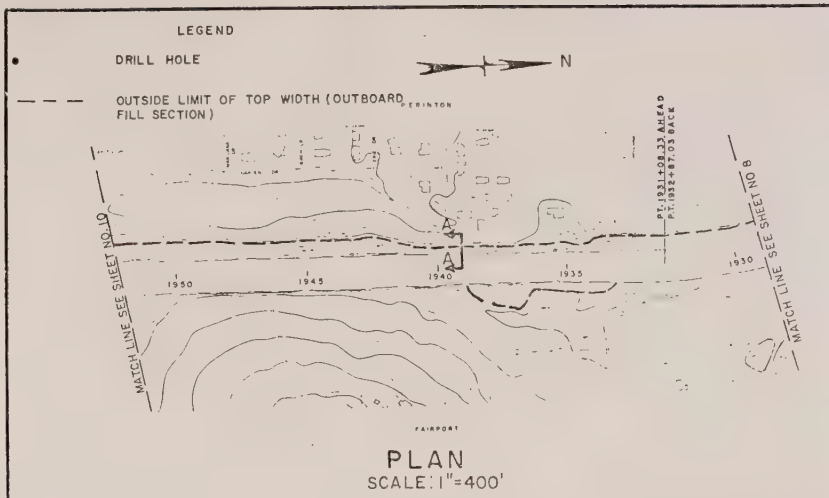
SECTION A-A  
SCALE: 1" = 20'

CANAL Q STATION 1930+00 - Q STATION 1952+00

Q 1938 TO Q 1940 - CLASS 2 (NORTH SIDE)  
REMAINDER OF AREA - CLASS 4

Q 1938 - Q 1940 - SUBSTANDARD EMBANKMENT SECTION  
REMAINDER OF AREA - NONE

Q 1939 - CULVERT NO. 37 OUTLET CLOGGED WITH SILT AND DEBRIS  
REMAINDER OF AREA - NONE

- WIDEN EMBANKMENT TO LIMITS SHOWN ON SECTION A-A
- CLEAN OUT AND EXTEND CULVERT NO. 37 TO LIMIT OF WIDENED SECTION AND IMPROVE HYDRAULICS AT OUTFALL TO PREVENT FURTHER SILTING

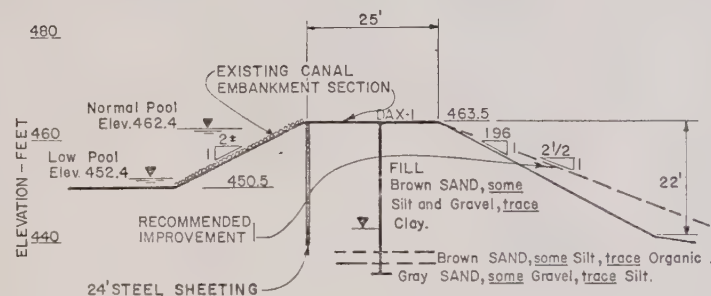
SECTION B-B  
SCALE: 1"=20'

CANAL Q STATION 1952+00 - Q STATION 1982+00

Q 1960 - Q 1969 - CLASS 2 (NORTH SIDE)

Q 1974 - Q 1982 - CLASS 3 (NORTH SIDE)

Q 1960 - Q 1982 - INTERMITTENT WET AREAS NOTED BELOW TOP WIDTH

NONE APPARENT - FURTHER INVESTIGATION OF TOWER FOUNDATION REQUIRED

- WIDEN EMBANKMENT TO THE MINIMUM LIMIT SHOWN ON SECTION B-B TO 1 ON 2.5 SLOPE BETWEEN Q 1960 AND Q 1969
- IN AREA WHERE CANAL LEAKAGE OCCURS, LEAKAGE CAN BE VIRTUALLY ELIMINATED BY EXTENDING EXISTING SHEETING AN ADDITIONAL 5± FEET 1' DEPTH FROM Q 1960 TO Q 1969 AND DRIVING NEW SHEETING FROM Q 1975 TO Q 1982

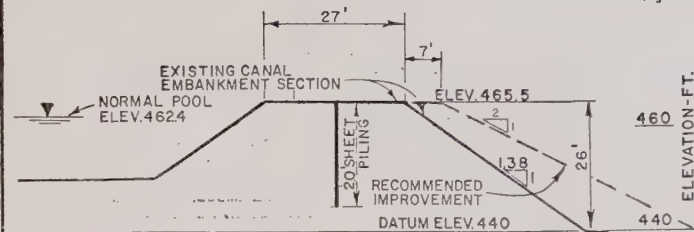
- Q 2007 - Q 2012 - INTERMITTENT SEEPAGE AREAS NOTED BEYOND TOE OF SLOPE
- DYE TEST PERFORMED AT Q 2012

- WIDEN EMBANKMENT TO LIMITS SHOWN ON SECTION C-C
- EXTEND CULVERT NO. 28 TO LIMIT OF WIDENED SECTION
- BORING AND PERIODIC FIELD MONITORING REQUIRED FOR SEEPAGE OBSERVED BETWEEN Q 2007 AND Q 2012
